SUMMARY OF DEFICIENCIES BY BUILDING

AQUATIC CENTER

AQUATIC FACILITY REVIEW
for
THE CITY OF MINERAL WELLS, TEXAS

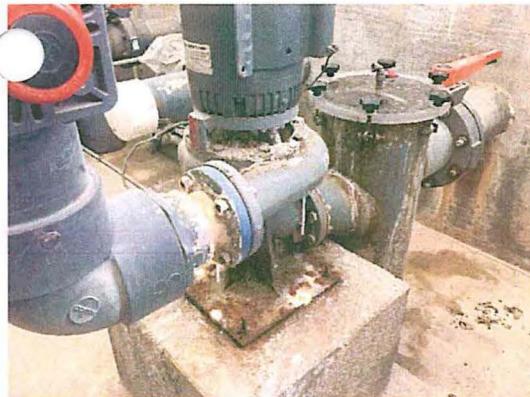
Existing pumps, motors, pump stands and strainers are rusted throughout.

Complete replacement of all pumps, pump motors, pump bases and pump strainers in the pump pit. (3 pumps and 3 strainers total.)

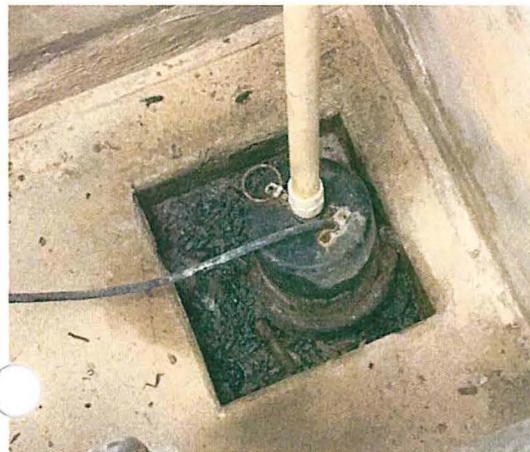
Sump in corner of pump pit is full of debris. Sump pump is probably no longer working. If the pump still runs, it could be damaged or ineffective if ever needed in the case of an emergency.

Clean the sump. Completely replace the sump pump and connect new pump to existing discharge piping.

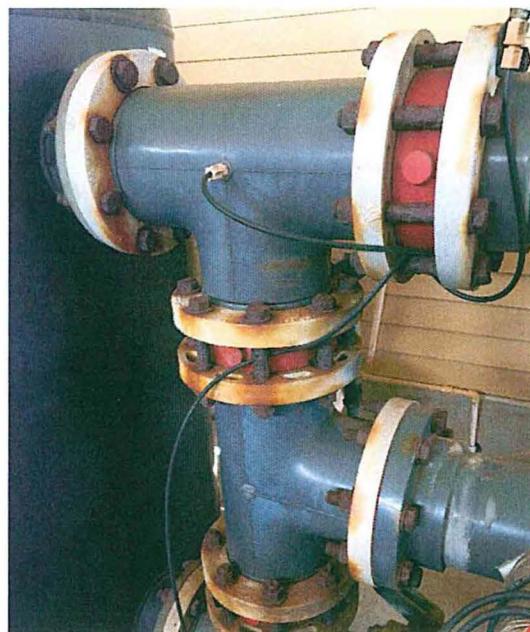
Rusted galvanized bolts throughout equipment room.

Replace all galvanized bolts with stainless steel bolts/hardware.

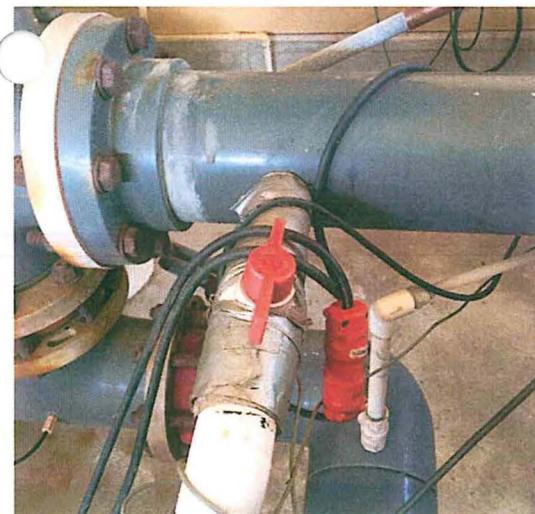
Over the years, it appears several plumbing connections have been made by tapping the main pipe headers. Leaking pipes "sealed" with duct tape and other sub-standard material.

Complete removal and replacement of all piping inside the pool equipment room. New piping will be schedule 80PVC. Pipe connections will be made with standard schedule 80 PVC fittings and saddles; no direct taps. Duct tape and temporary repair materials will be removed and should not be allowed during repairs (whether temporary or permanent repairs).

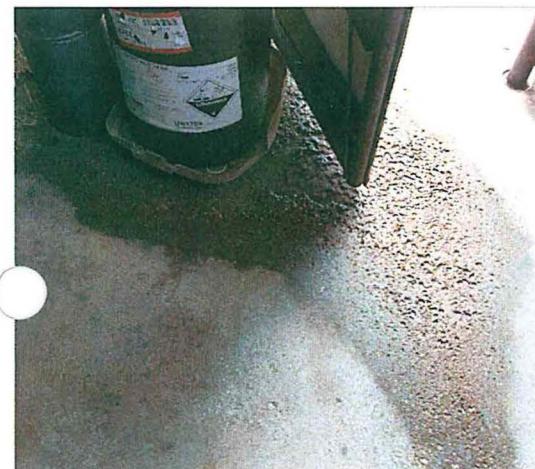
Acid spill(s) with insufficient containment have deteriorated the concrete slab in the equipment room in two locations.

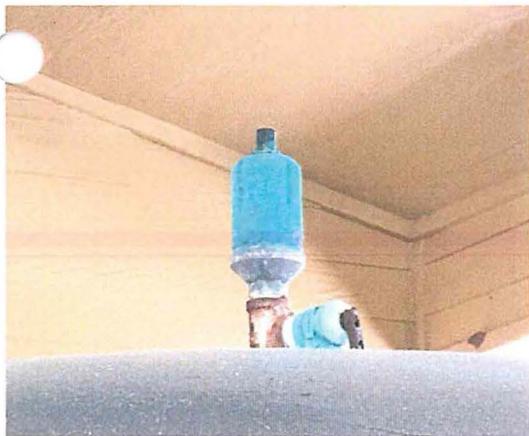
Relief valve at top of steel filter tanks are heavily corroded. Filter "legs" are heavily rusted. Vertical steel filter tanks are inherently subject to corrosion due to rust. There are much newer filter technologies that utilize fiberglass materials and polymers that will not rust.

City staff indicated that the filter internals may be broken as evidenced by noticeable sand in the pools on occasion.

Complete removal and replacement all vertical steel filter tanks and replacement with new fiberglass filters of equal size. The replacement will include new filter face piping and manual backwash controls (to match the existing system).

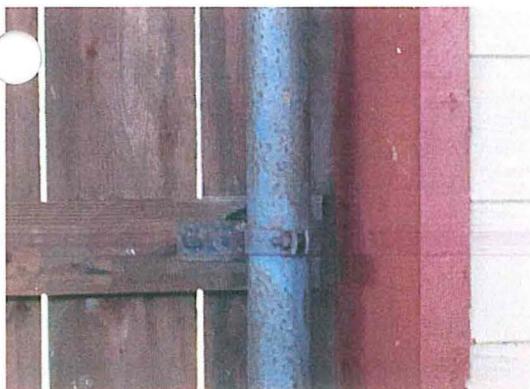
Galvanized piping supports inside the pool equipment room are rusted.

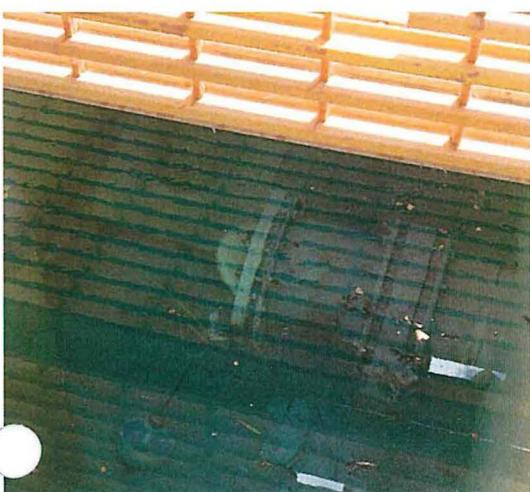
Float-style modulating valve in the surge tank is broken.

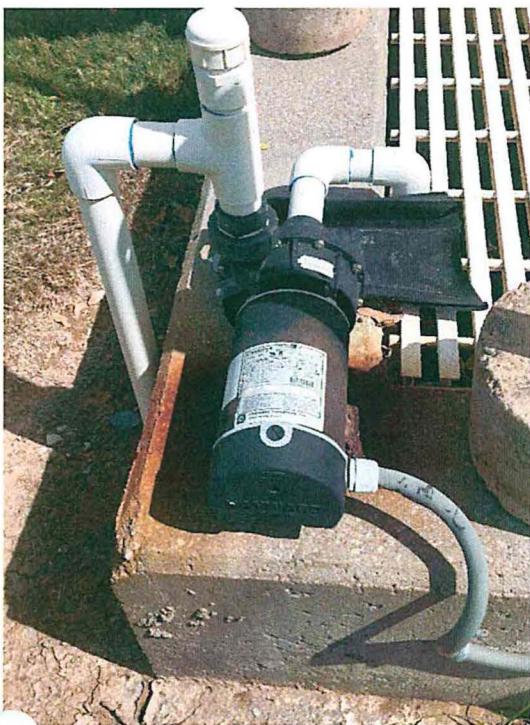
Small, self-priming pump has been installed on the top of the surge tank for water supply to the waterslide that was installed after original construction.

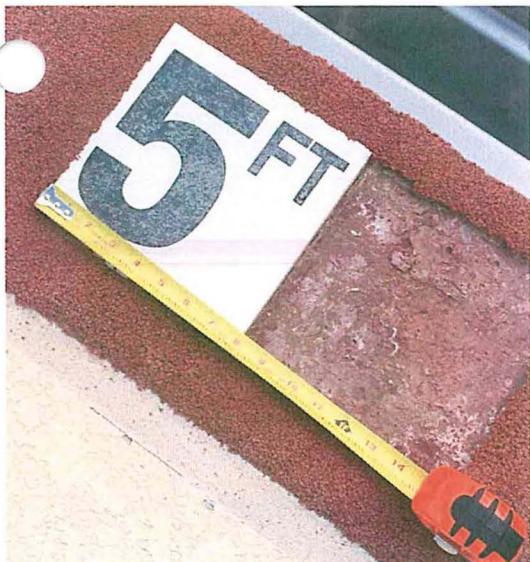
Some depth marking tiles are missing or damaged.

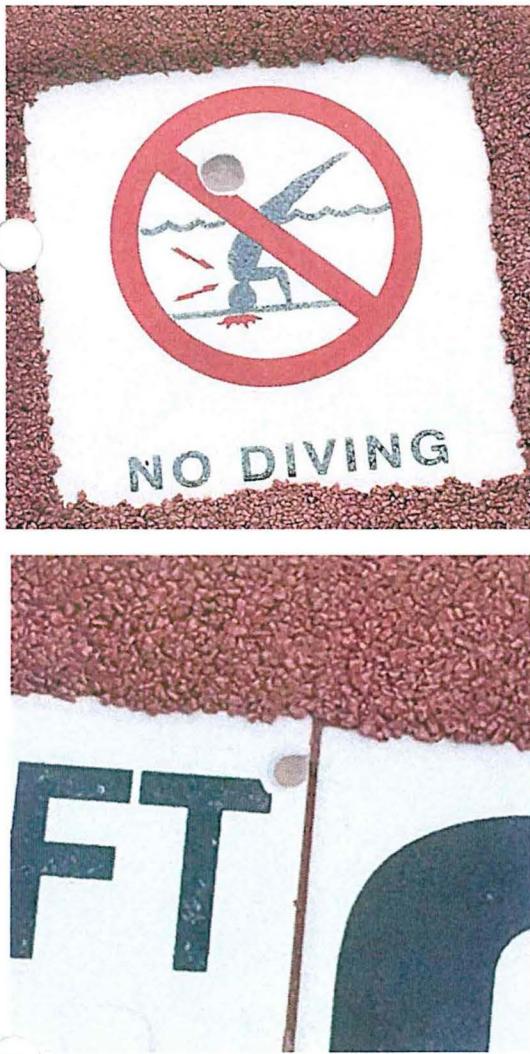
Damaged spots on several deck tiles around the pools.

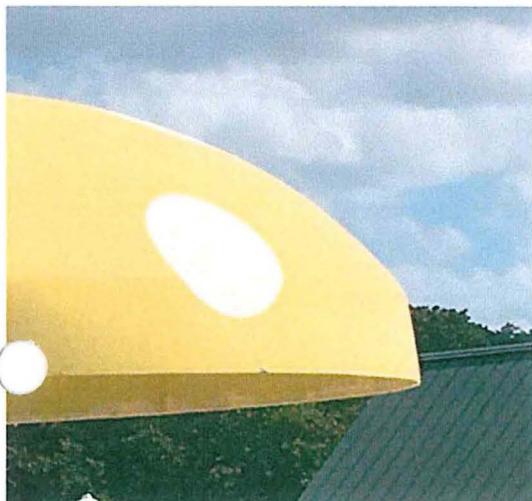
Crack in the upper fiberglass canopy of the "mushroom" fountain. City staff has indicated that internal piping inside the feature is rusted.

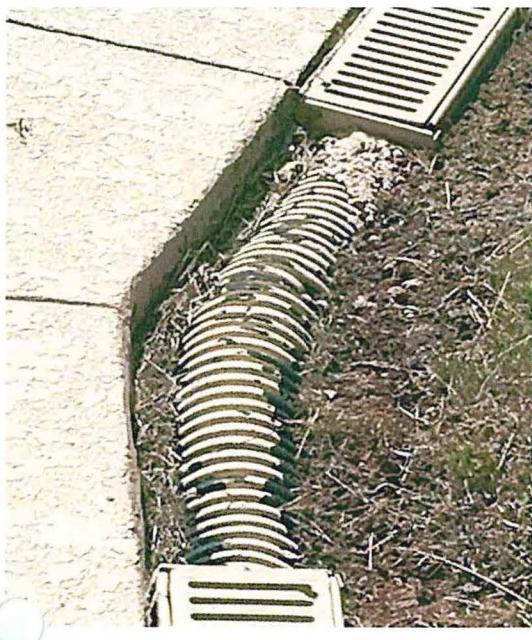
Exposed corrugated drain piping around the perimeter of the pool deck is often damaged, cut, or broken. The piping should have been installed so that there were outlets on the bottom of the trench drains that connect into a buried storm sewer header.

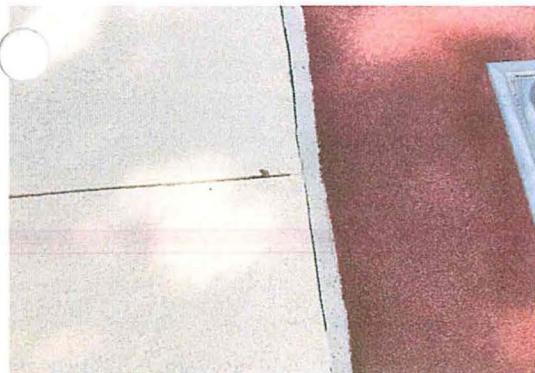
Deck joint sealants are beginning to pull away from the deck in places.

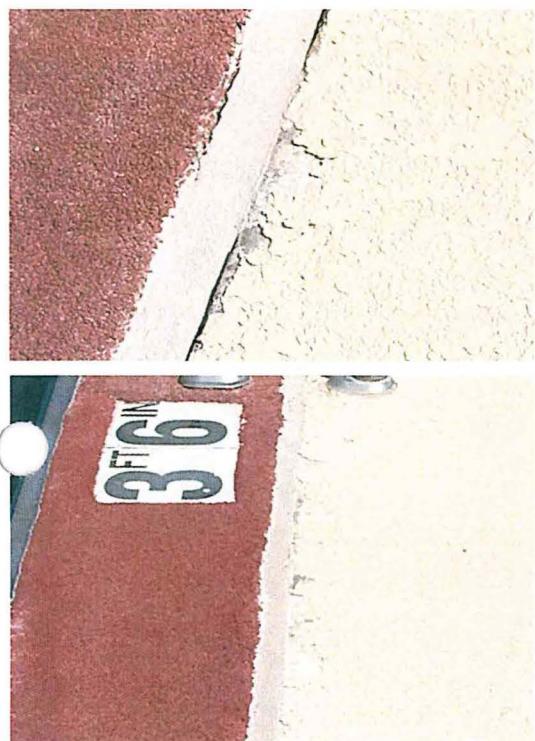
Several locations where the acrylic or cementitious deck coating is beginning to chip or peel.

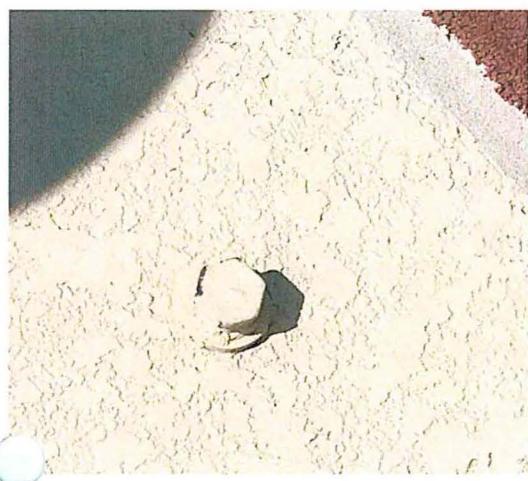
Plug in a PVC pipe protrudes vertically from the pool deck near the shallow water, beach entry pool.

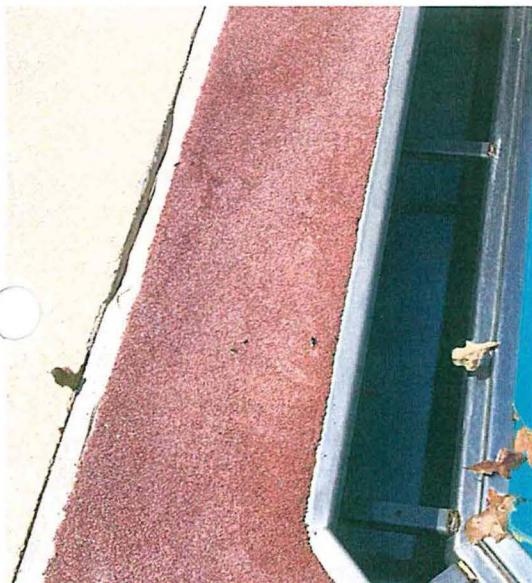
There appears to be a small leak behind the stainless steel gutter near the southwest corner of the shallow water pool. The leak has caused separation between the pool deck and the apron behind the pool gutter. In addition, the leak has caused displacement of the expansion joint sealant and discoloration of the granulated rubber material installed on the apron behind the gutter.

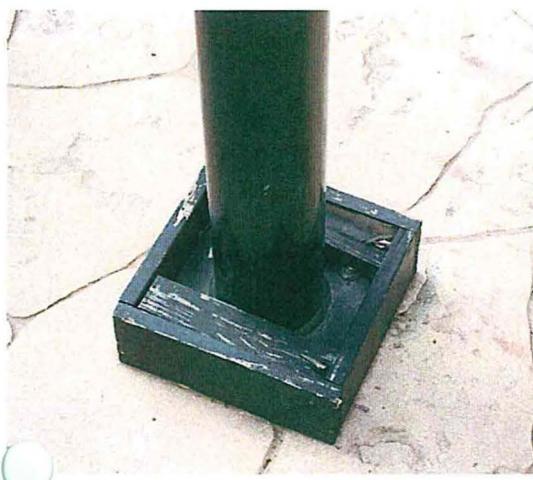
The painted wood framing around the base plates of the shade canopies offers some protection to patrons, but doesn't appear to be completely safe.

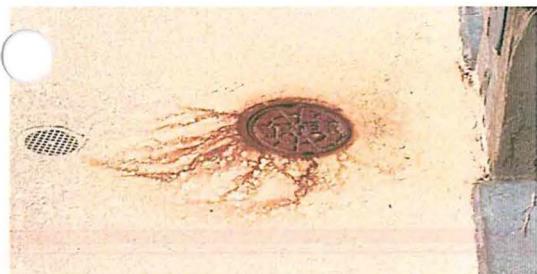
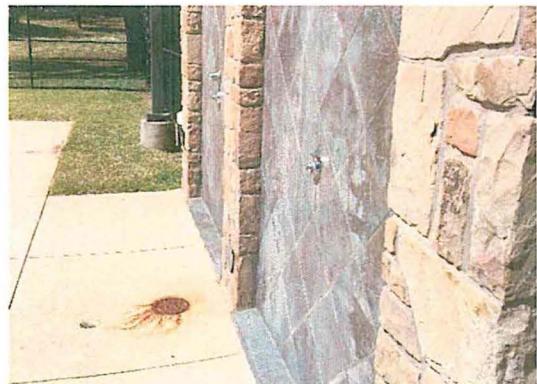
Cast iron water valve cover rusting onto pool deck.

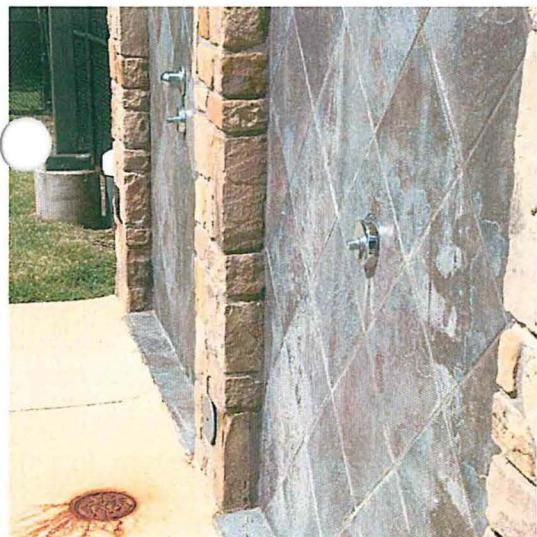
Calcium staining on the tiled shower walls.

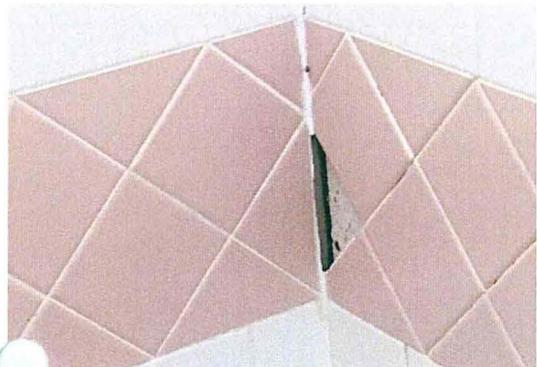
Broken tiles at several locations in restrooms and showers.

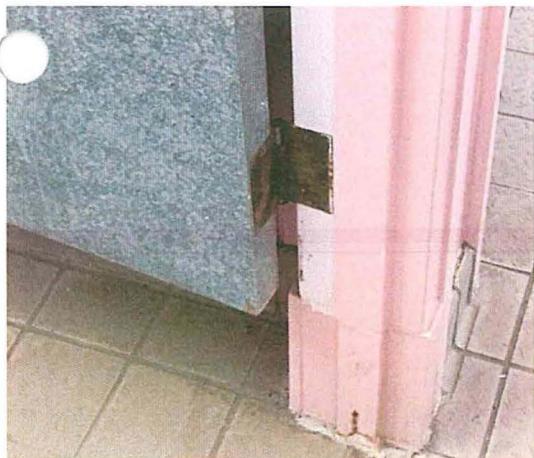
Hinges and hardware on restroom stall doors are rusted.

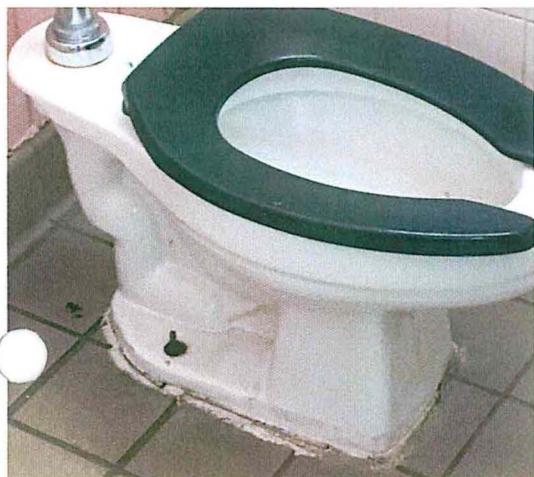
Rusted bolts on toilets in restroom.

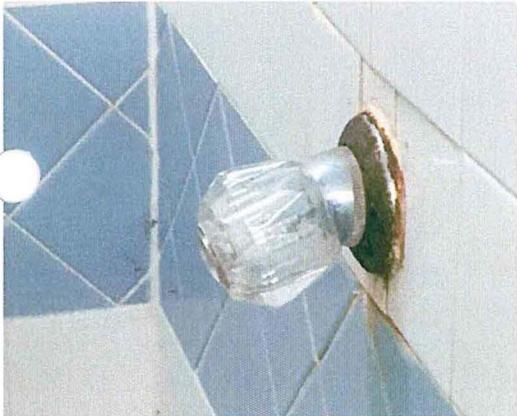
Hardware in shower stall is severely rusted. Hardware in accessible showers does not appear to be ADA- and TAS-compliant.

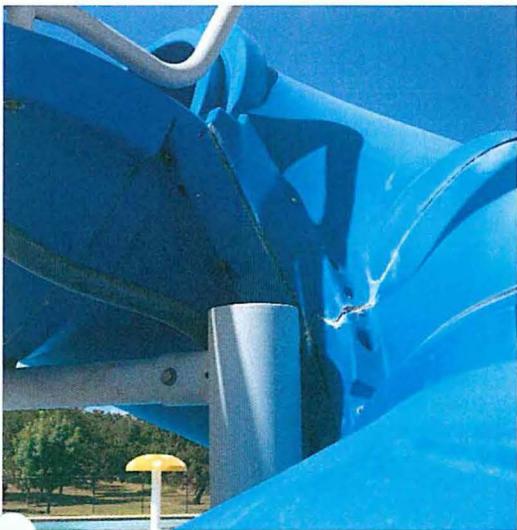
Caulk in joints of outdoor waterslide is becoming worn and may fail soon. Waterslide needs to be relocated so it no longer conflicts with the diving board. City staff indicated that waterslide piping leaks considerably due to lack of proper fittings/gaskets at initial installation.

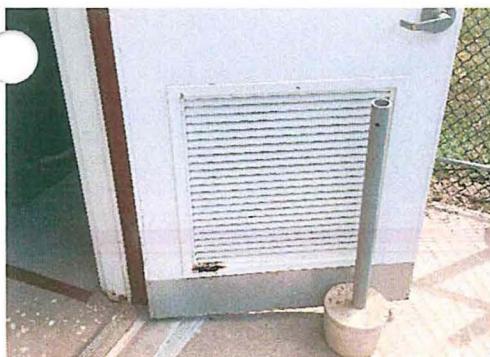
Louvered openings on doors are beginning to rust.

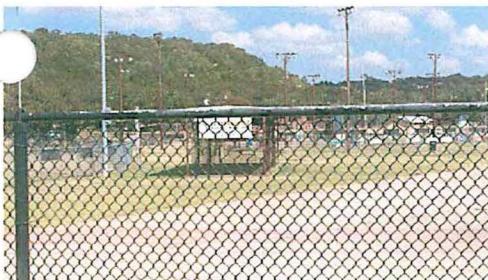
Black vinyl coating is beginning to fail on the top rail of perimeter chain link fencing around the pool area. Chain link fabric is being held to fence with plastic zip ties in several locations.

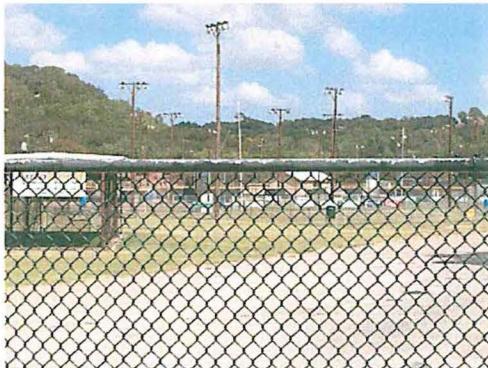
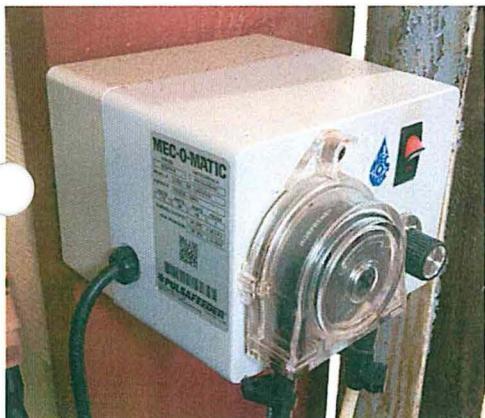
The age and dependability of the peristaltic acid pumps is uncertain. The acid pumps may require replacement soon.

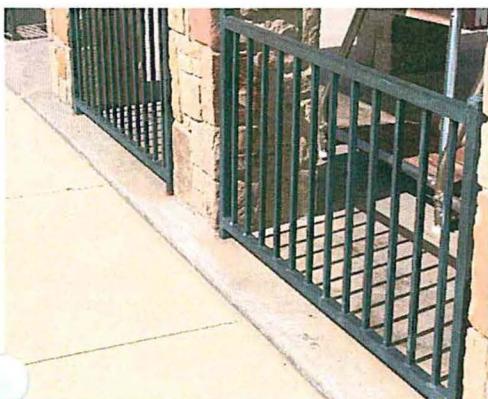
Iron picket fencing is rusting near the ground.
