SUMMARY OF DEFICIENCIES BY BUILDING

AQUATIC CENTER

AQUATIC FACILITY REVIEW
for
THE CITY OF MINERAL WELLS, TEXAS

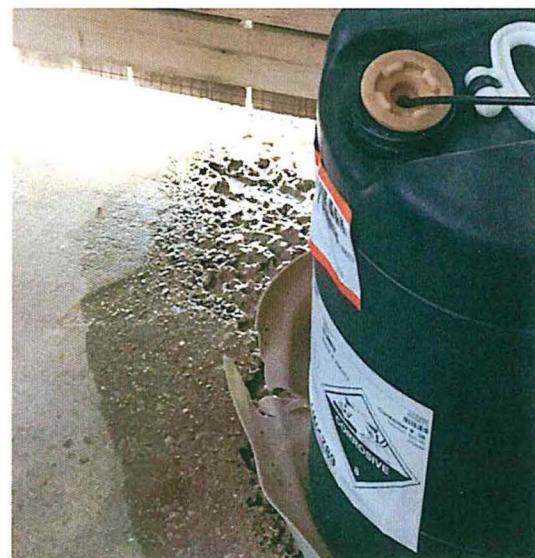
Acid spill(s) with insufficient containment have deteriorated the concrete slab in the equipment room in two locations.

RECOMMENDATION:

(NOTE: This item is not required, but recommended for pool operator safety.)
